THI QAR VILLAGE ROADS
SEGMENT 3
GOVERNORATE OF
THI QAR, IRAQ

SIGIR-PA-06-059
OCTOBER 26, 2006

SUBJECT: Report on Project Assessment of Thi-Qar Village Roads Segment 3 Project,
Thi-Qar, Iraq (Report Number SIGIR-PA-06-059)

Thi Qar Village Roads – Segment 3 Governorate of Thi Qar, Iraq

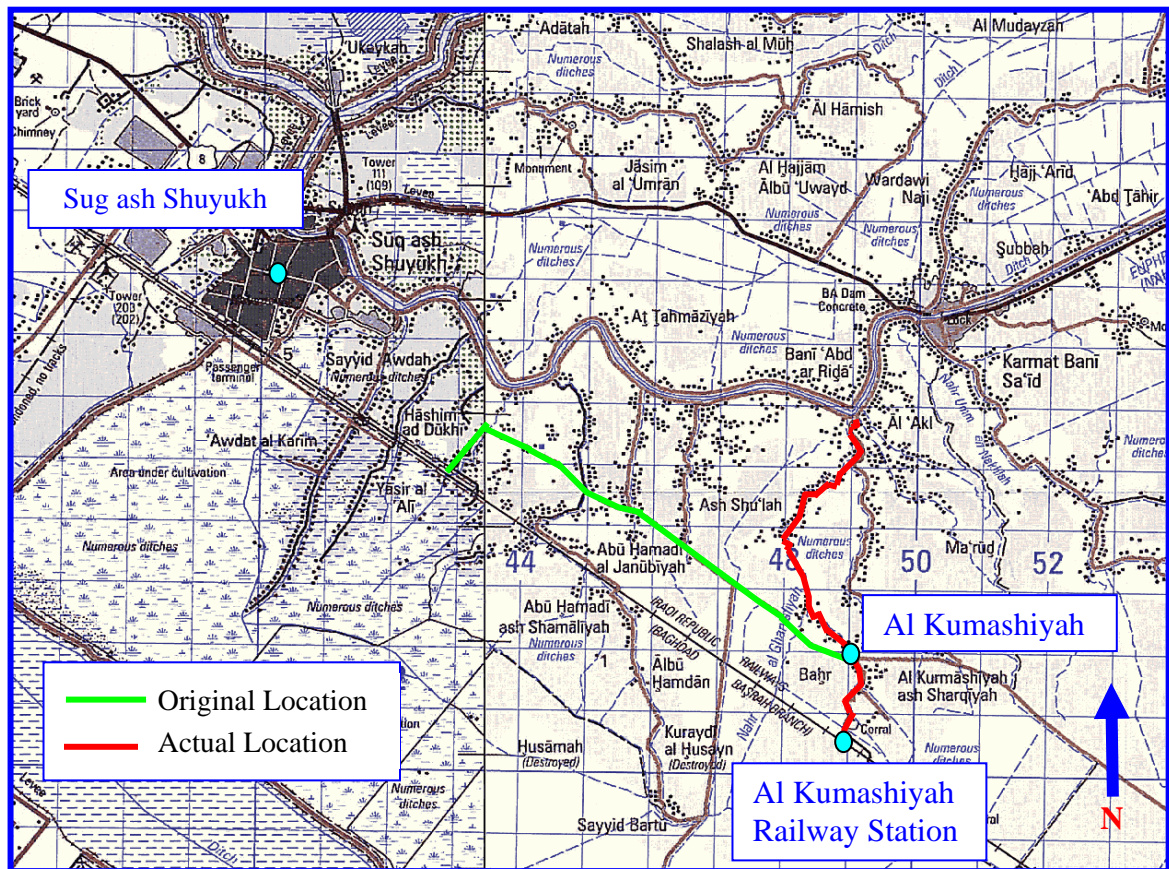
The grid coordinates provided by the SCRB delineated the alignment shown in red in Figure 1. The new alignment parallels an irrigation canal and runs in a north-south direction. The northern terminus of the road is at the Euphrates River. The road ends in the south at the Al Kumashiyah Railway Station.

Figure 1: Thi Qar Village Roads Segment 3 Project

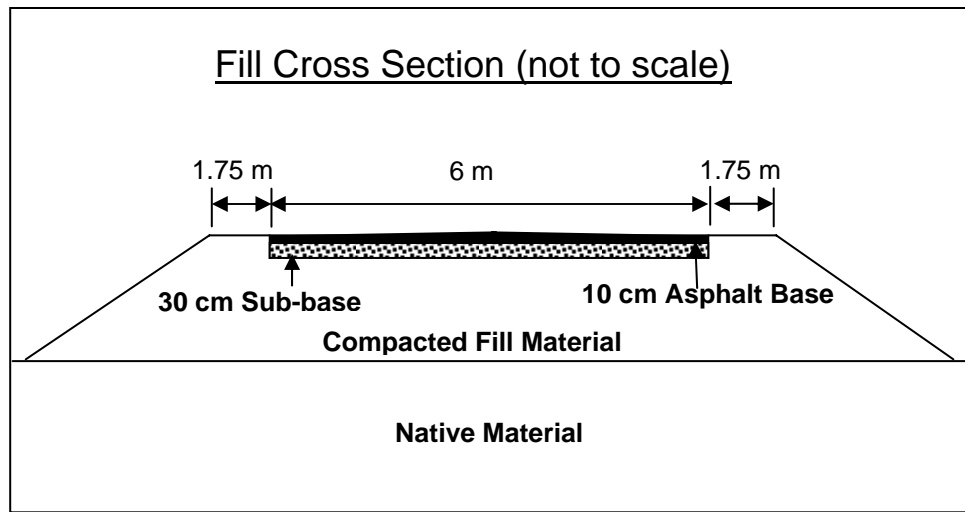
Figure 2. Typical fill cross section

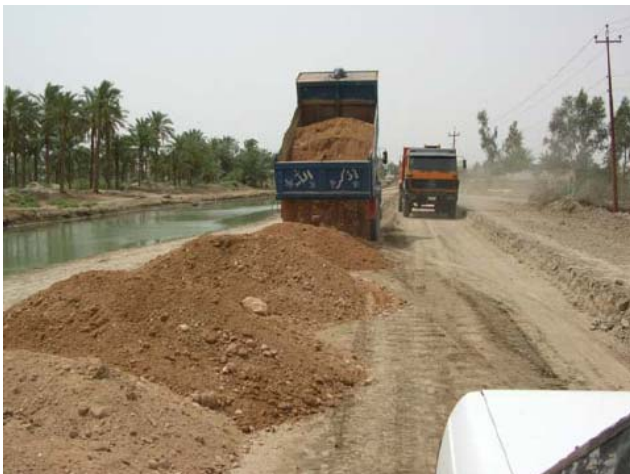
Site Photo 1. Trucks delivering material to the roadway (Photo provided by USACE)

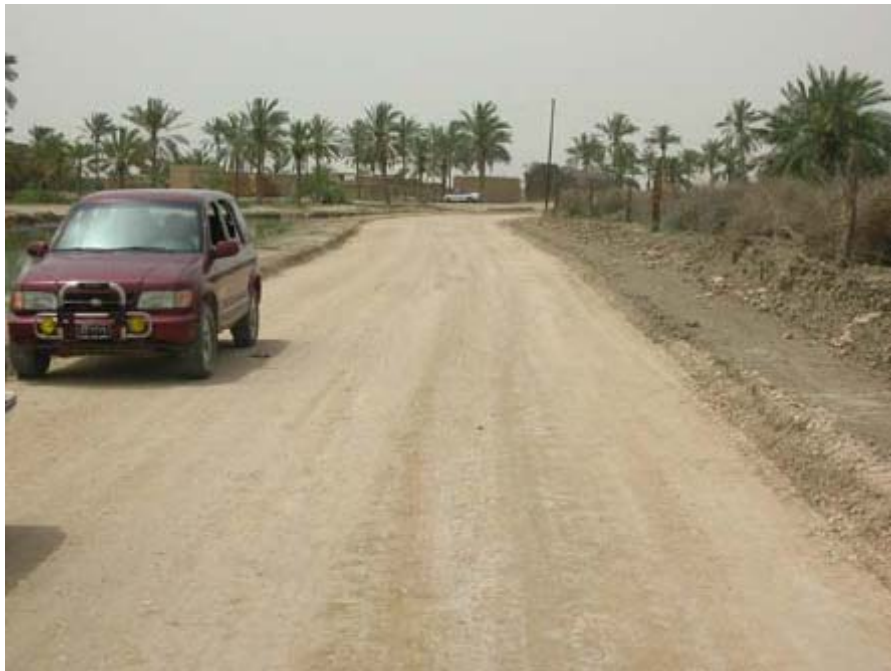
Site Photo 6. Compacted sub-base. (Photo provided by USACE)

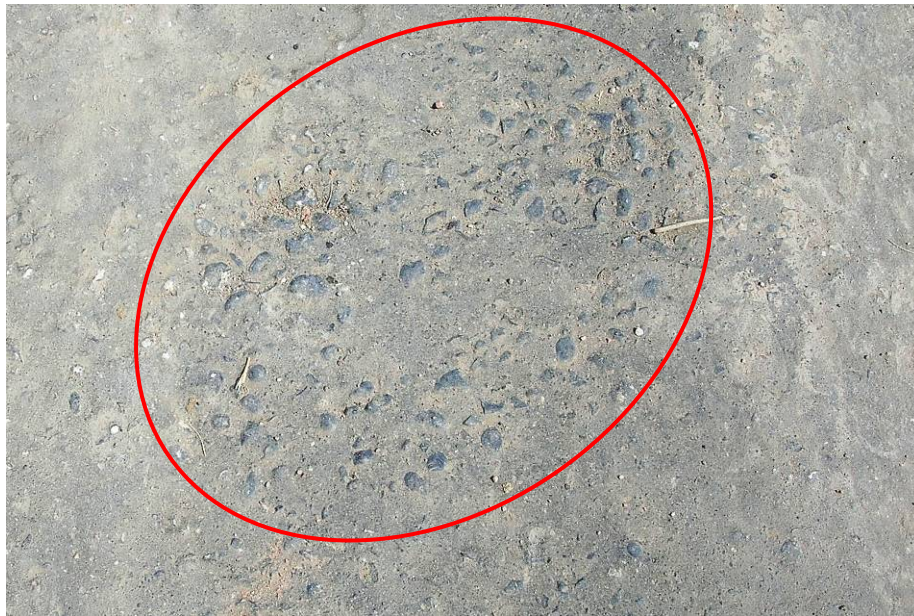
construction. The USACE RE indicated on 17 July 2005, that within the first 500-750 meters of the project from the railroad station (*the southern limit of the project*), the asphalt appeared to have too much aggregate on the top layer (Site Photo 7).

Site Photo 7. Exposed aggregate on surface of asphalt base course.
(Photo provided by USACE)

Based on the contractor's response to the USACE RE, the mix contained a higher proportion of course aggregate. Although the contractor indicated a mix with a higher proportion of course aggregate provided grater stability (against rutting), the pavement was also subject to increased possibility of cracking and potential raveling. Nonetheless, the contractor stated they would repair the section in question by overlaying base course with a fine mix of asphalt.

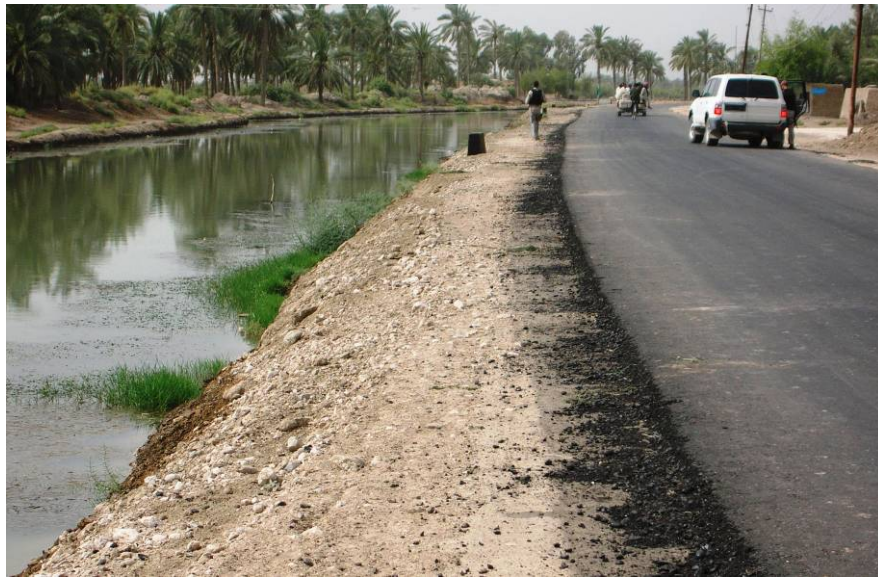
The other issue noted by the USACE RE was the outside edge problem as shown in Site Photo 8. In correspondence to the contractor, the USACE RE stated:

"Ideally, there should be a definitive borderline along the side of the asphalt road and the shoulder. In other words, you should be able to clearly see where the asphalt stops and the shoulder starts."

Site Photo 8. Outside pavement edge with a non-uniform edge. (Photo provided by USACE)

The contractor indicated the edge would be corrected when the shoulders were constructed.

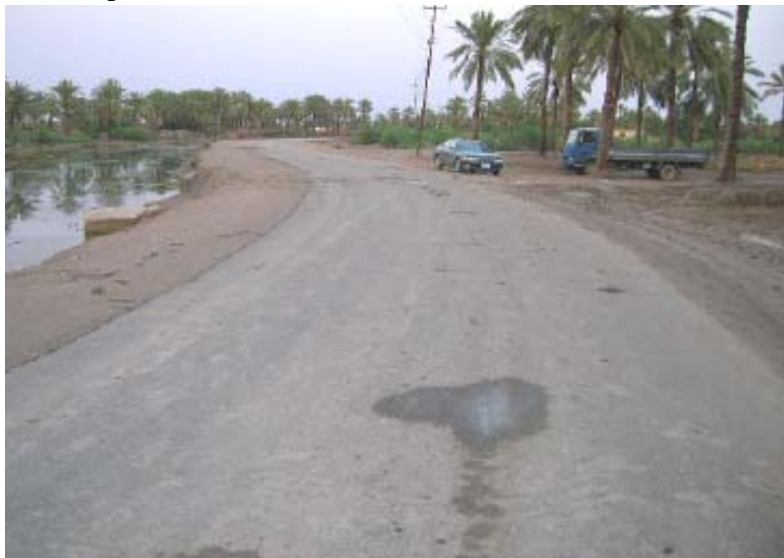
In addition to reviewing the QA reports, the USACE Resident Office in April 2006, dispatched an Iraqi local national QAR to the project site to inspect the Thi Qar Village Road, and take pictures showing current conditions. The assessment team reviewed the photos taken by the USACE QAR and the condition of the pavement appeared to be in satisfactory condition, except for some mud on the road. The photos did not reveal any surface deficiencies such as cracking, rutting, raveling, or potholes. The minor discrepancies noted during the inspection process do not appear to have adversely affected the overall condition of the road. Site Photos 9 and 10 show the condition of the Thi Qar Village Road in April 2006, approximately 9 months after completion.

Site Photo 9. Curved section of Thi Qar Village road in April 2006. (Photo provided by USACE)

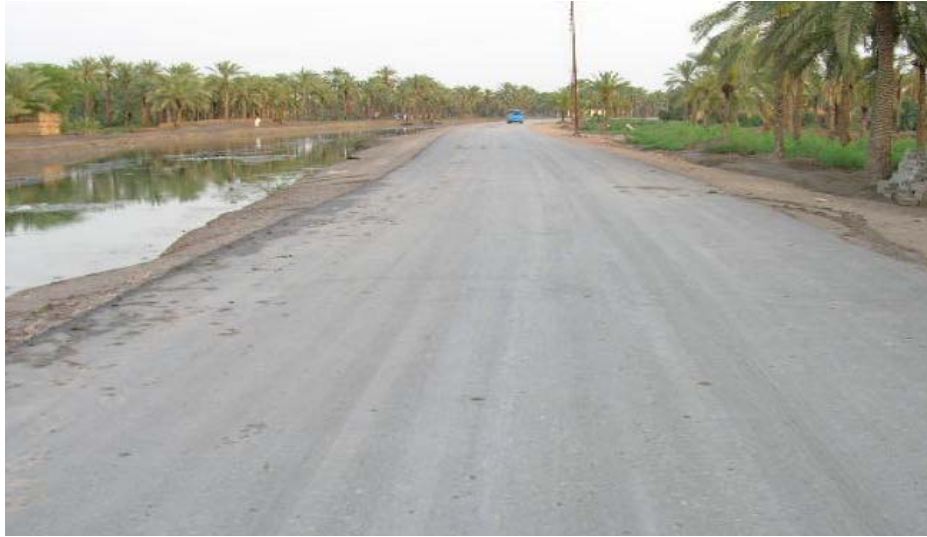
**Site Photo 10. Straight section of Thi Qar Village road in April 2006.
(Photo provided by USACE)**
